A Summary of Earthquake Reconnaissance Efforts of the Multidisciplinary Center for Earthquake Engineering Research

MCEER RESPONSE

PRELIMINARY REPORTS FROM THE KOCAELI (IZMIT) EARTHQUAKE OF AUGUST 17, 1999

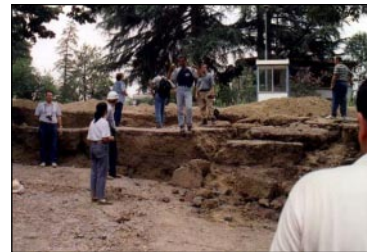
Surface faulting near Golcuk.

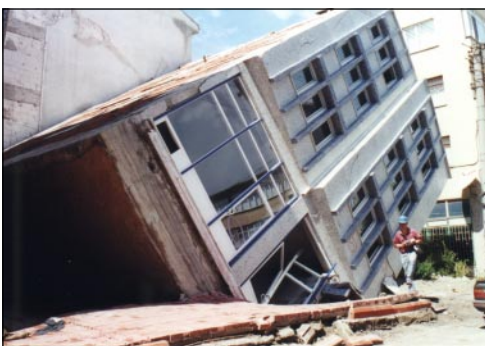
Figure 1. One example of foundation failure.

Foundation failures were observed for a large number of buildings with large settlements, and in some cases, entire structures overturned.

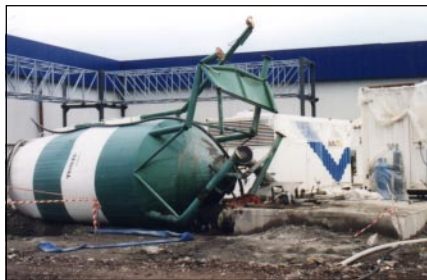
Typical causes for collapses include failure of anchor bolts at column bases and structural instability under overturning forces. Other evidence of damage include

Figure 4. The anchor bolts ruptured and the unbraced support legs buckled, causing this water tank to tip.

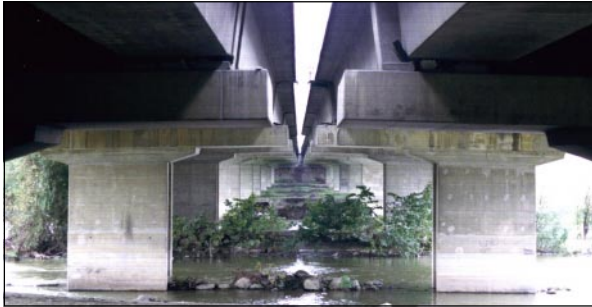
evidently for accommodating longitudinal thermal movements. The large impulsive fault-normal ground shaking coupled with high vertical accelerations caused several spans to fail the shear keys and unseat from their bearings. This is shown in Figure 3. The bridge has been closed to traffic awaiting repairs. The east-bound sister bridge sustained less damage to the shear

Figure 3. The east (left) and west (right) bound bridges over the Sakarya River. Note shifting of the spans and the unseating of the bearings in the west-bound bridge. The bearings on the east-bound bridge have partially "walked out," but not unseated.

keys and only partial walk-out of the bearing pads; complete unseating did not occur and the bridge has remained fully operational.

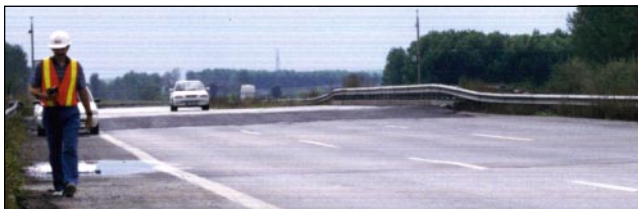
The extent of damage to the engineered fills on the E80 motorway extended some 10 km to the west and east of the Adapazari area. Settlements ranging from 100 mm to 500 mm were observed. This was evident at most single span bridge and culvert locations on that road, resulting in classic bump-onto-the-bridge problems. One example is shown in Figure 4. Repair of this damage was swift. Initial repairs, made in the first few days following the earthquake, consisted of placing asphalt ramps and maintaining a 50 km/h speed restriction. Within 10 days, more long-term

Figure 4. A typical view of the bump-onto-the-bridge on the E80 motorway. Up to 500 mm embankment settlements were common over a 20 km stretch of road. Notice the guard rail in the photograph as further evidence of the embankment settlement.

repairs were made. Re-profiling and re-paving large stretches of the road surface enabled the speed restrictions to be removed and the motorway returned to its normal 120 km/h operating speed.

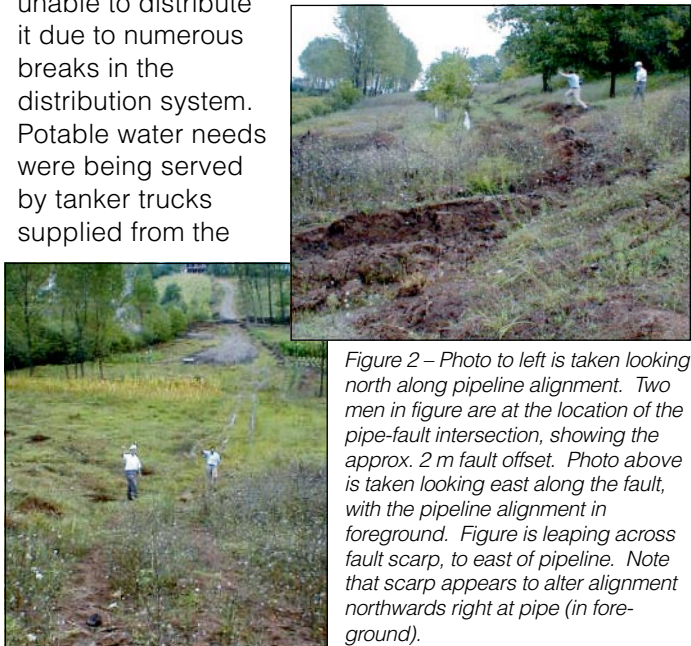
Approximately 1 km downstream of the plant, the steel transmission line crosses the fault trace. This location was inspected and found to have approximately a 2 m right lateral offset but, while some water flowing to the surface was observed (it was raining at the time, however), the pipe was reportedly undamaged at this location (see Figure 2).

Figure 2 – Photo to left is taken looking north along pipeline alignment. Two men in figure are at the location of the pipe-fault intersection, showing the approx. 2 m fault offset. Photo above is taken looking east along the fault, with the pipeline alignment in foreground. Figure is leaping across fault scarp, to east of pipeline. Note that scarp appears to alter alignment northwards right at pipe (in foreground).

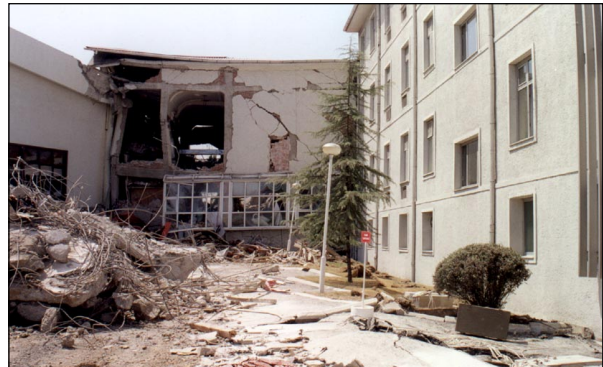
One building is totally collapsed while another is hardly damaged on the Naval Base in Golcuk.

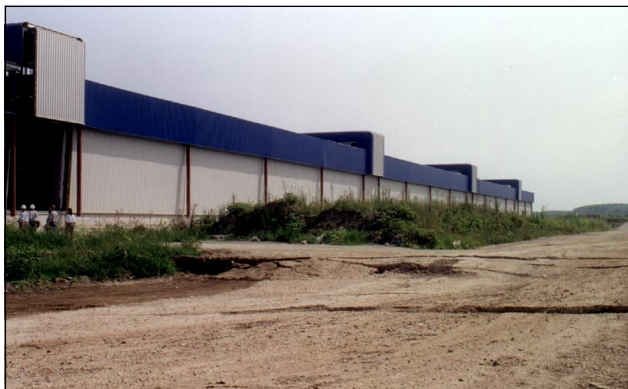
The fault rupture is visible next to this damaged manufacturing facility, under construction at the time of the earthquake.
